Manhole Inspection Summary

Manhole # S35WW_086MH

Insp Date: **10/30/08 10:11 AM**

Location Address: **3001 BARCLAY ST**

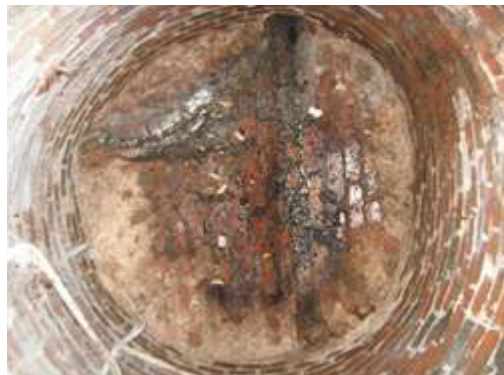
Top View

Channel debris.

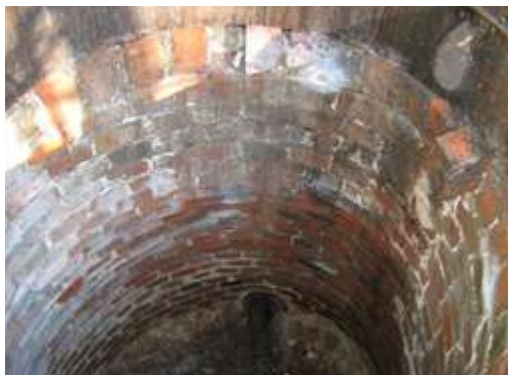
Defect

Condition: ☐ Sound ☐ Cracked ☐ Root Intrusion ☒ **Loose Brick** ☒ **Deteriorated**

Infiltration: ☐ None ☒ **Joint** ☐ Cracks ☐ Mortar ☐ Roots ☒ **Wall**

Infiltration: ☐ None ☐ Joint ☐ Cracks ☐ Mortar ☐ Roots ☒ **Wall**

Adjustment deterioration, loosebrick and infiltration. Barrel infiltration.

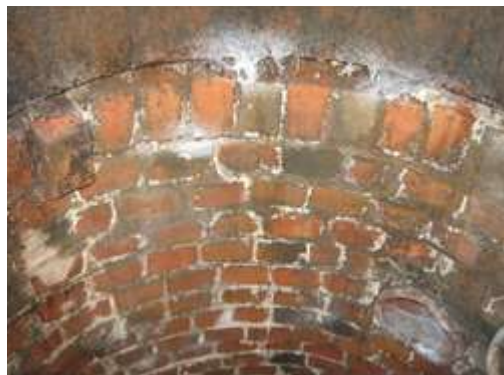
Defect

Adjustment deterioration, loosebrick and infiltration. Barrel infiltration - other side.

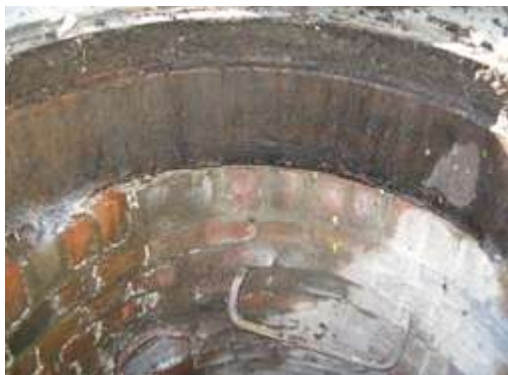
Defect

Adjustment infiltration.

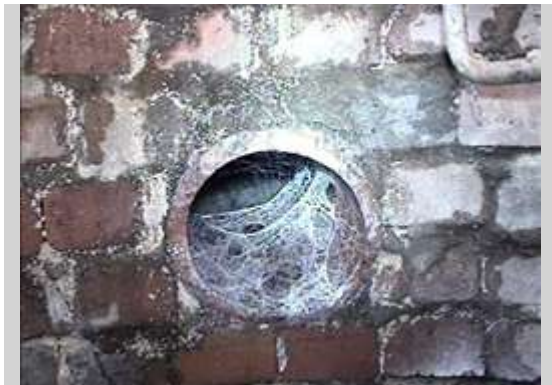
6 in. Circular Gravity Sewer Pipe In @ 5 O'Clock

Deposits: ☐ None ☐ Mud ☐ Sludge ☐ Debris ☒ Grease

Silt Depth: **0** (in.) Deposits Extent: **Light**
